IMPROVED MATERIALS AND MANUFACTURING
METHODS FOR GUN BARRELS. PART I

SWERR-TR-72-54

**IMPROVED MATERIALS AND MANUFACTURING
METHODS FOR GUN BARRELS
(PART I)**

August 1972

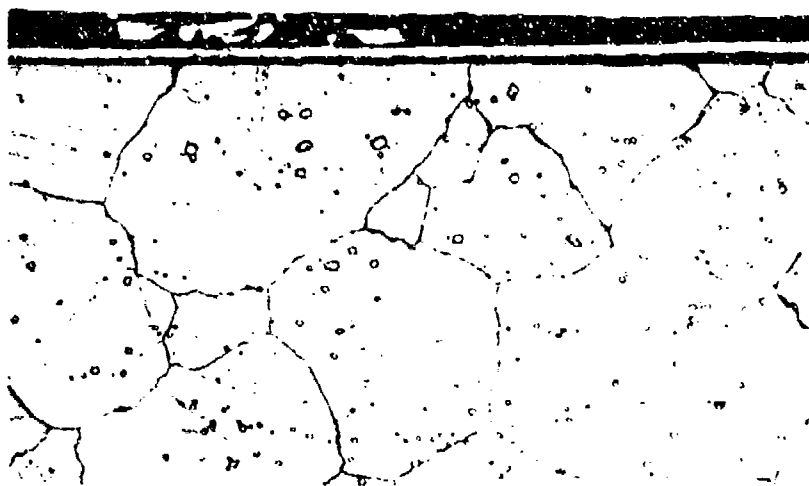
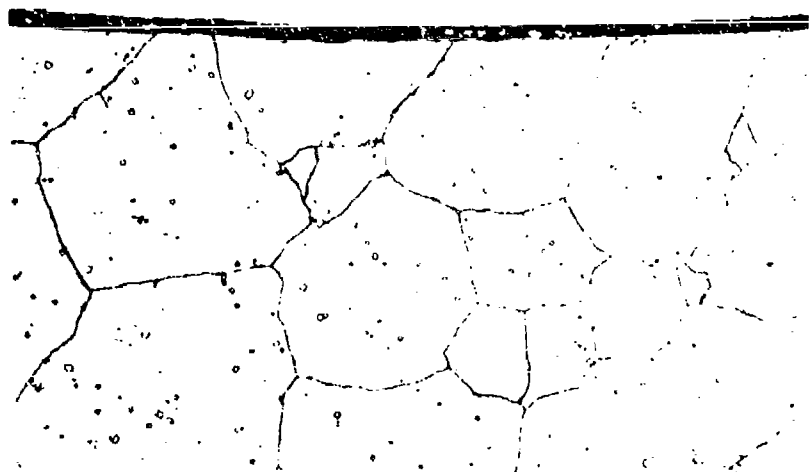
Figures 36 and 37 are typical photomicrographs along the bore surface of the L605 inserts which had received 1 and 5 shots. The surfaces have been nickel plated. Cracking is readily apparent in the insert which received 5 shots.

FIGURE 36 PHOTOMICROGRAPHS SHOWING THE STRUCTURE ALONG THE BORE SURFACE OF AN I605 ALLOY INSERT AFTER ONE VENTED BOMB SHOT WITH WC846 PROPELLANT. (5% CHROMIC OXIDE ELECTROLYTIC ETCH)

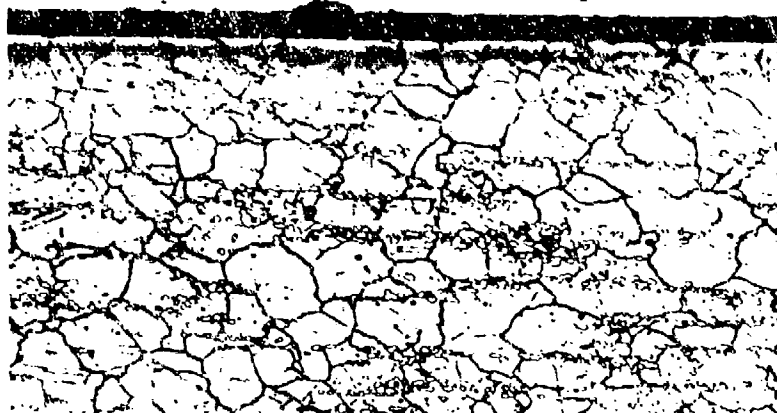
Figures 38 and 39 typify the metallurgical structure along the bore surface of the HS-31 alloy after 1 and 5 shots in the vented bomb. The surfaces were nickel-plated to preserve the as-fired bore surface. The cracks which occurred in these specimens were very fine and few in number. The areas shown do not have an appreciable evidence of cracking.

FIGURE 39 PHOTOMICROGRAPHS SHOWING THE STRUCTURE ALONG THE BORE SURFACE OF AN HS-31 ALLOY INSERT AFTER FIVE VENTED BOMB SHOTS WITH WC846 PROPELLANT. (5% CHROMIC OXIDE ELECTROLYTIC ETCH)

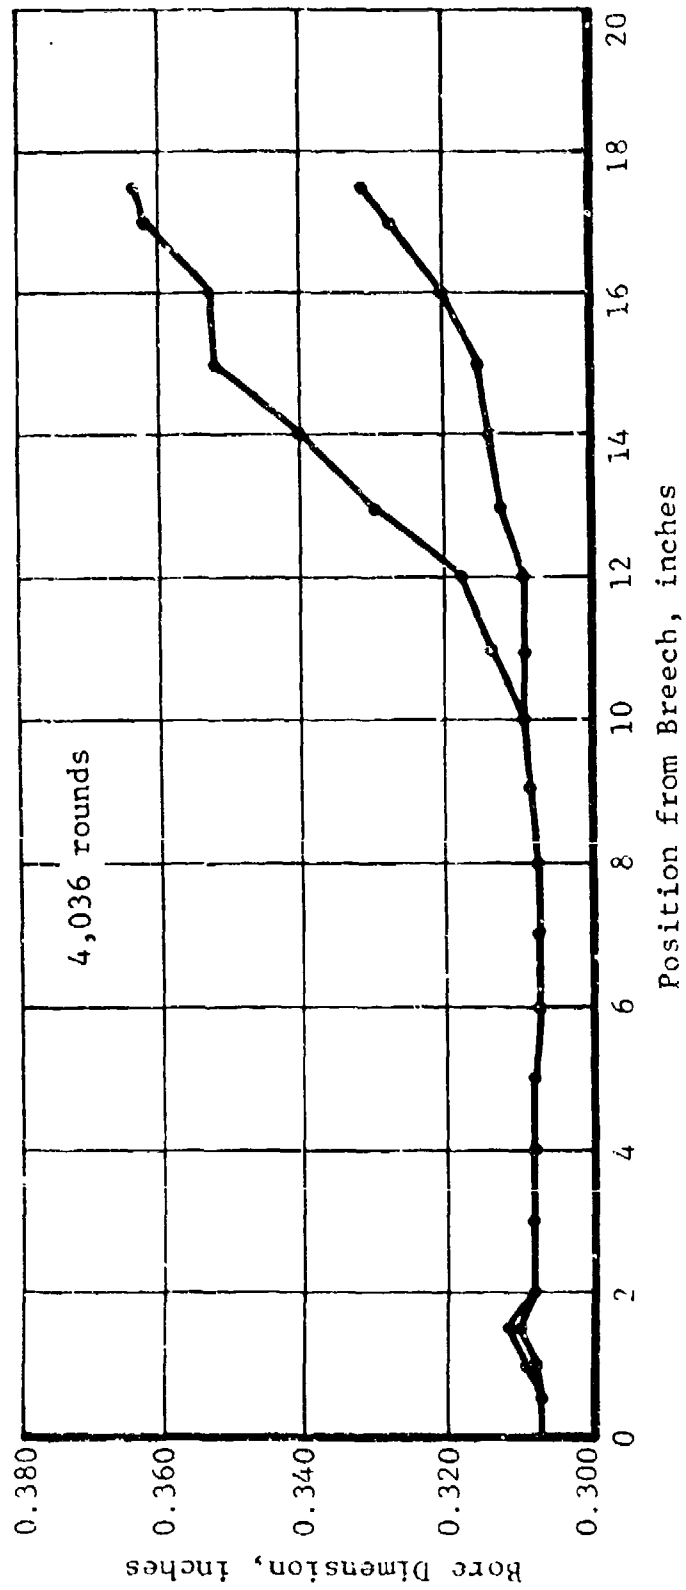
FIGURE 44 BORE PROFILE FOR CG-27 MATERIAL FOR 4036 TOTAL ROUNDS FIRED.

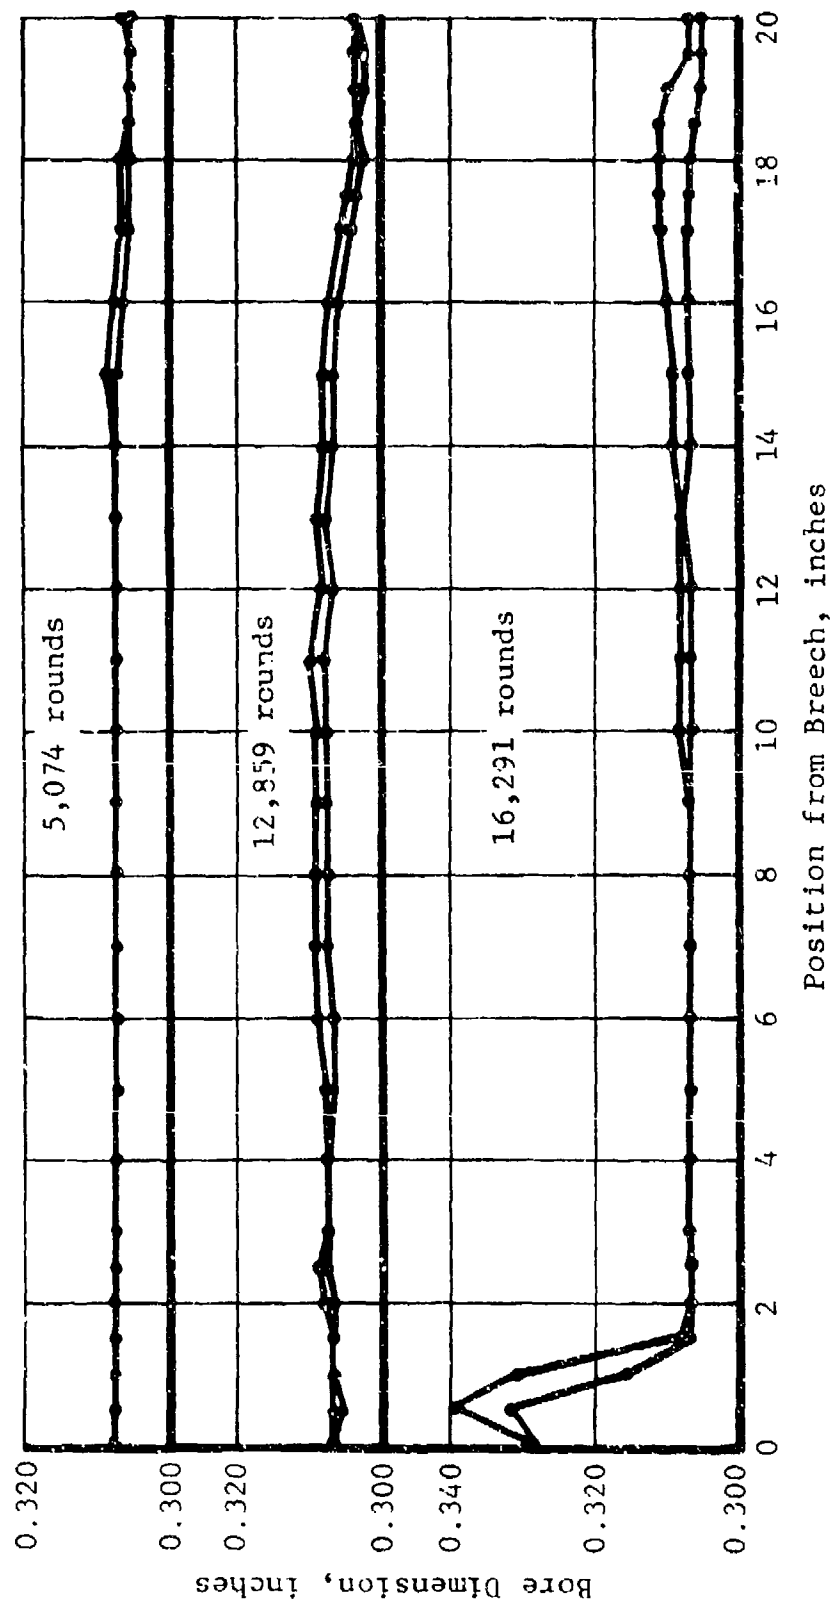
FIGURE 45 BORE PROFILE FOR H11 MATERIAL FOR VARIOUS NUMBERS OF TOTAL ROUNDS FIRED.

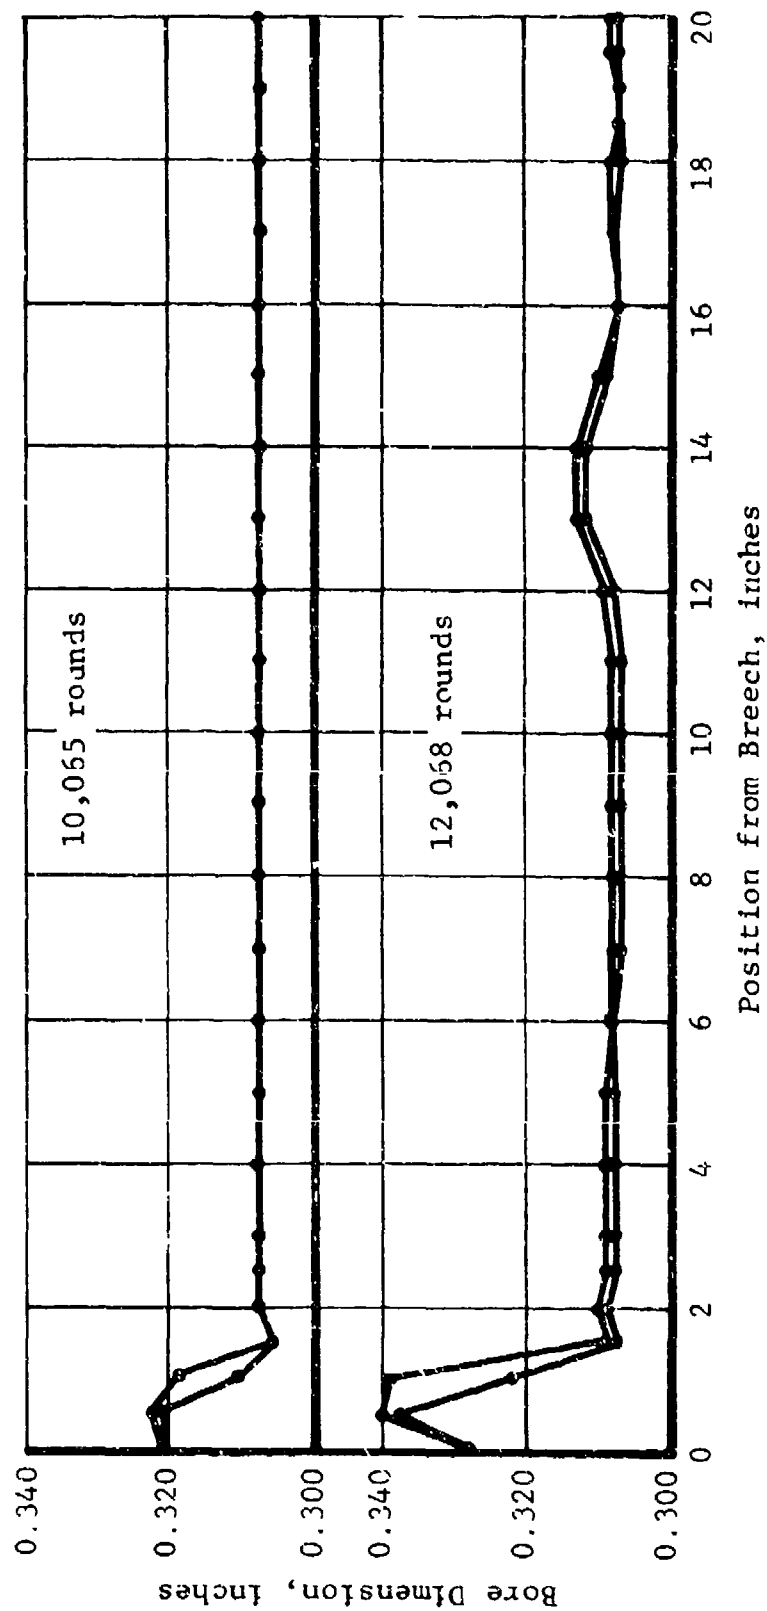
FIGURE 47 BORE PROFILE OF STANDARD STEEL BARREL FOR VARIOUS NUMBERS OF TOTAL ROUNDS FIRED.

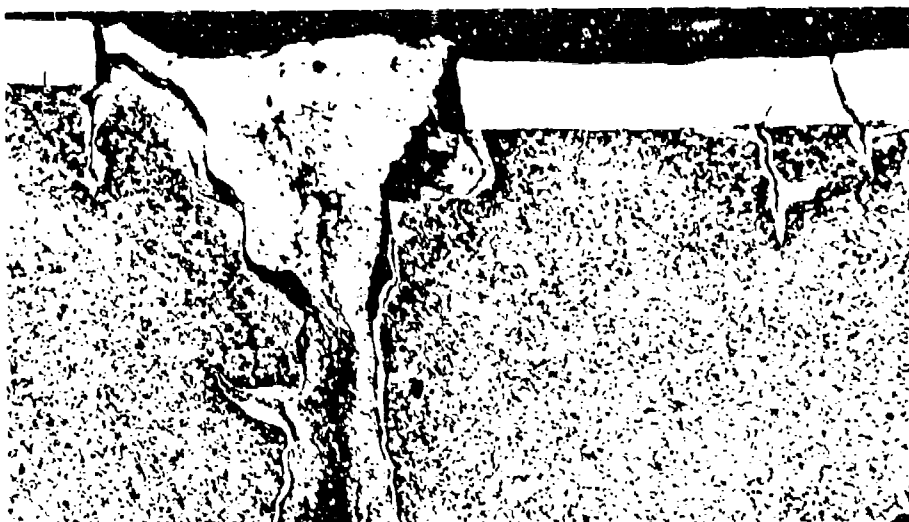
FIGURE 57 TRANSVERSE SECTION AT 2 INCHES FROM THE CHAMBER OF A STANDARD CHROME-PLATED GUN BARREL AFTER FIRING 12,068 ROUNDS AND BEING DECLARED UNSERVICEABLE.

At the 2 inch position, there are relatively large cracks in the chrome plate and the steel. Figure 57 shows a portion of the transverse section. The characteristic features are the presence of the copper alloy in the cracks, the discontinuous white layer, the change in structure to ferrite and carbide near the crack and bore surface, and the presence of most of the chrome plate.

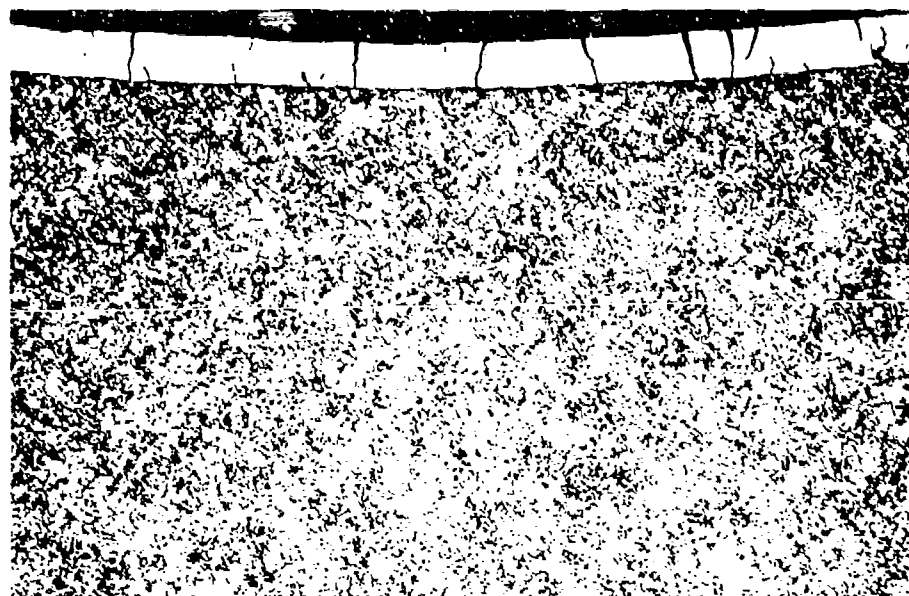
FIGURE 58 TRANSVERSE SECTION AT 10 INCHES FROM THE CHAMBER OF A STANDARD CHROME-PLATED GUN BARREL AFTER FIRING 12,068 ROUNDS AND BEING DECLARED UNSERVICEABLE.

Figure 58 shows the typical appearance of the transverse section at 10 inches. The cracks in the chrome-plate can readily be seen; however, the general integrity of the region is good. Further examination of the sample revealed a thinning of the chrome plate on the barrel similar to that of Figure 52.
